**Awareness Home Inspection Services, LLC**  
**443 538 6921**  
**inspectorcharlie@gmail.com**

# Inspection Report

**Property Address:**  
123 Sample Lane  
Confusion Md 00000

<b>Date:</b> 1/6/2010	<b>Time:</b>	<b>Report ID:</b> 010610A
<b>Property:</b> 123 Sample Lane Confusion Md 00000	<b>Customer:</b> My Customer	<b>Real Estate Professional:</b>

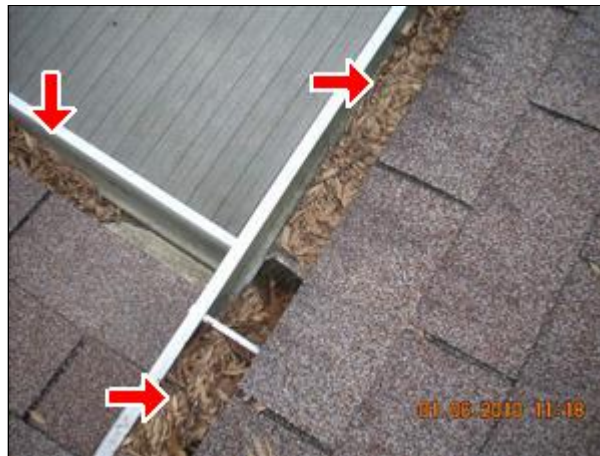
2.1 Picture 1

The gutters are full of debris in areas and need to be cleaned by any qualified person. The debris in gutters can also conceal rust, deterioration or leaks that are not visible until cleaned, and I am unable to determine if such conditions exist.

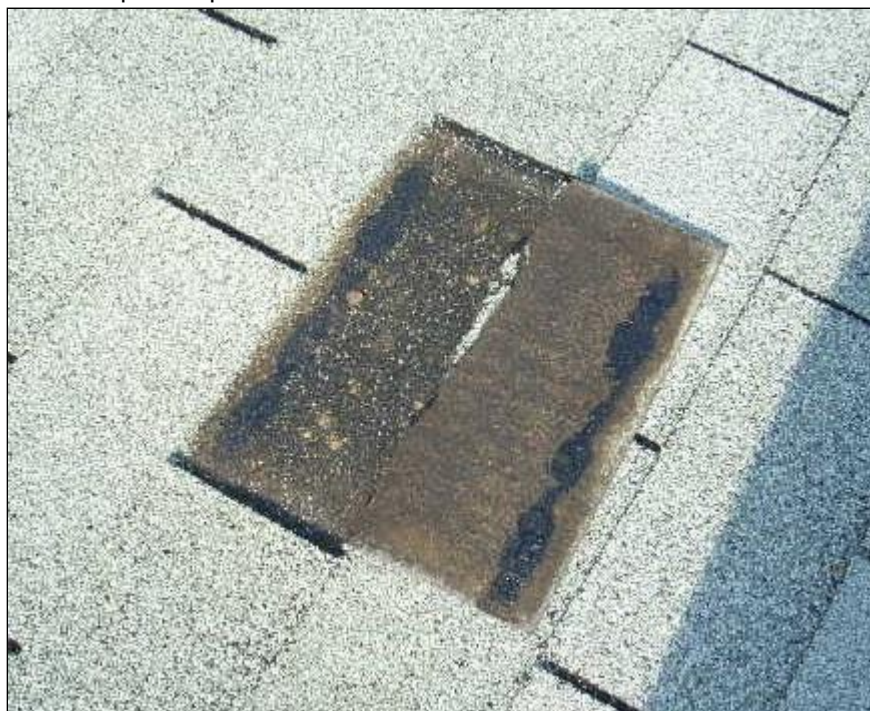
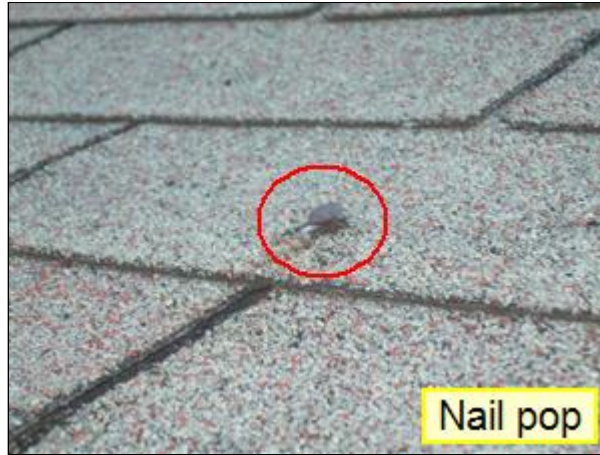
2.2 Picture 1

The roof has some damaged shingles and nail pops which can allow water intrusion into the home. Additionally, there is water damage that can be seen from the attic near the chimney. Engage a MHIC licensed roofing contractor to repair the shingles and nail pops, and inspect for where the water is leaking into the home near the chimney, to reduce the potential of moisture intrusion and further damage. This roof appears to near the end of its normal life expectancy and the roofer may recommend complete replacement.

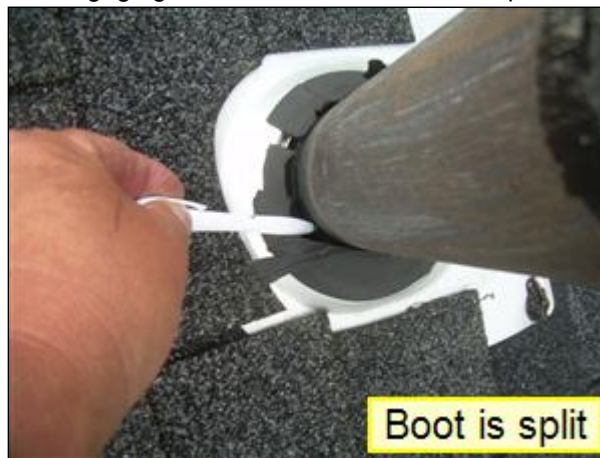
2.3 Picture 1

The rubber boot around the plumbing vent stack is split. This can allow water intrusion into the home. Caulking will give you a year or two of additional life but engaging a MHIC licensed roofer to replace the boot is better.

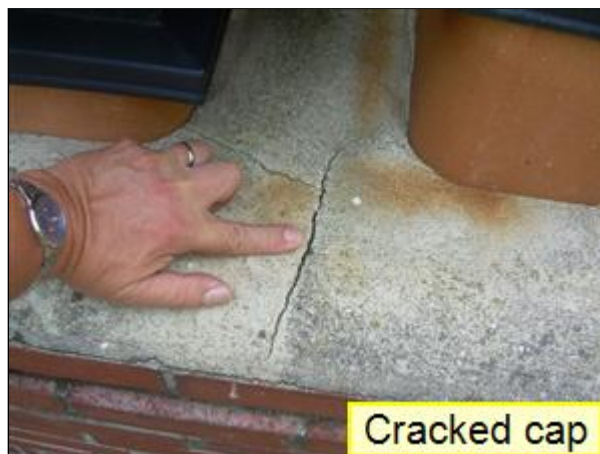
2.5 Picture 1

The masonry chimney cap is cracked. This can allow water and ice to get in and under the bricks and loosen or damage the bricks. Engage a MHIC licensed chimney sweep or MHIC licensed masonry contractor to inspect and repair.

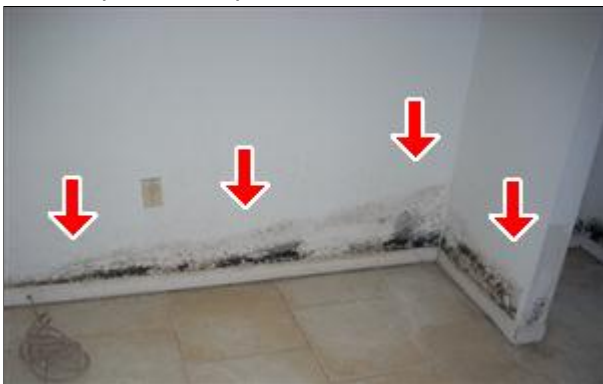
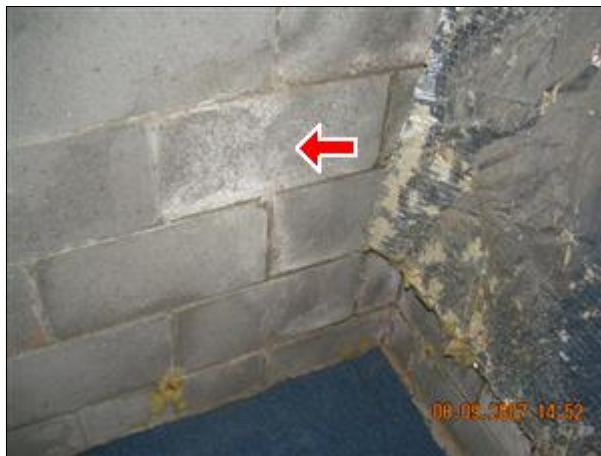
3.0 Picture 2

(2) Major; It is obvious water is coming into the basement at the laundry room wall. The drywall with fungal growth needs to be removed and possibly some of the wood framing behind the drywall. Water intrusion may be caused by lack of adequate grading outside or the clogged gutters overflowing. I recommend engaging a MHIC licensed contractor to inspect and repair as needed.

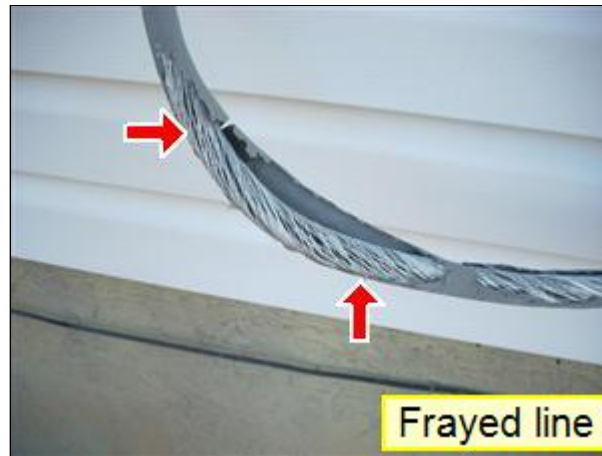
4.0 Picture 1

The covering on the service line outside of the home is frayed and someone could get an electrical shock. Engage a licensed electrical contractor to replace the weathered service cable to reduce potential of fire hazard and personal injury.

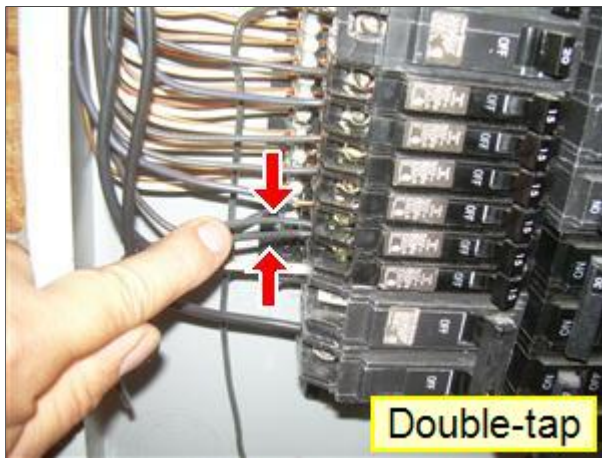
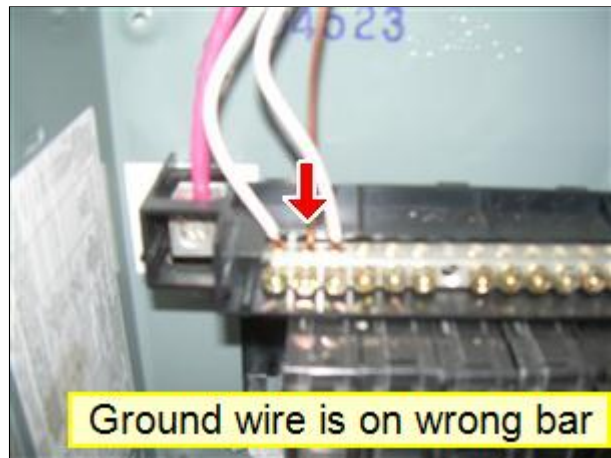
4.1 Picture 1

Engage a licensed electrician to inspect and rewire the secondary panel as needed. The ground wires and neutral wires need to be separated in a secondary panel and there is one ground wire in the secondary panel that is attached to the floating neutral bar.

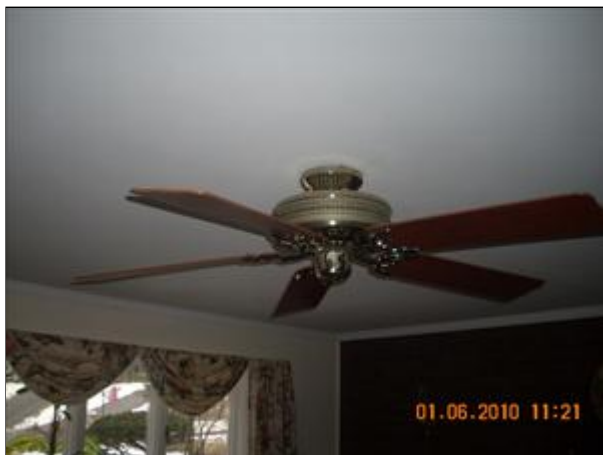
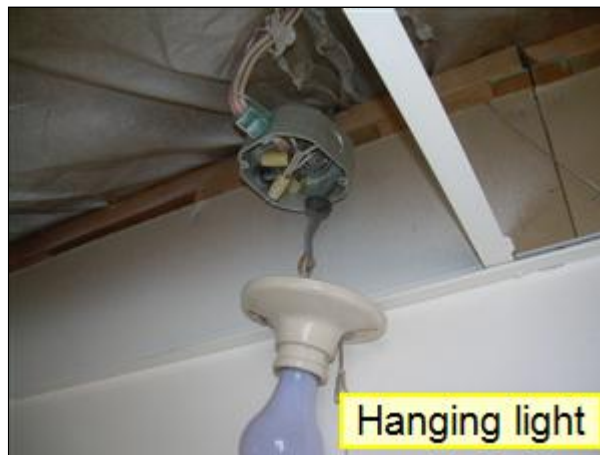
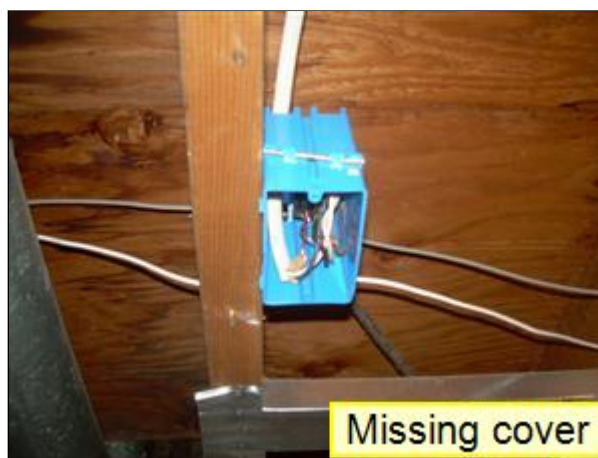
4.3 Picture 1

The ceiling fan "wobbles" dining room. This is a simple repair, have a qualified person balance the fan.

The light fixture is damaged and at the rear of the basement. Electrical issues are considered a hazard until repaired. A qualified licensed electrical contractor should perform repairs that involve wiring.

Replace the missing cover on the junction box on the rear ceiling basement to reduce the potential for injury.

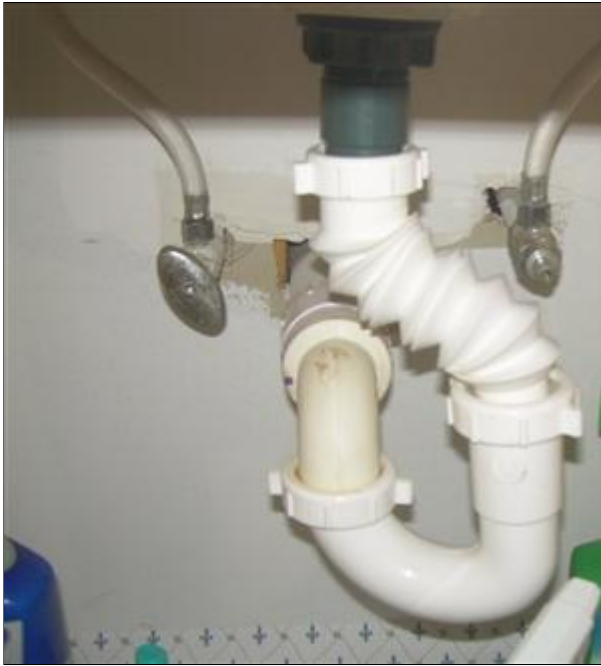
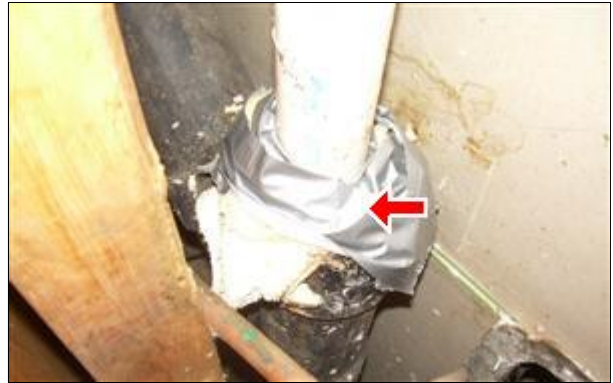
5.0 Picture 1

Many "do-it-yourselfers" use the flexible traps for remodeling. All waste and drain lines are required to have smooth interiors so these flexible traps cannot be considered as permanent. Replace the temporary repair trap parts under the sink in the hallway bath with UPC approved parts to reduce the potential of leaks or flooding.

Engage a licensed plumber to repair the incorrect waste drain/air vent connection behind the basement access panel for the basement bath to reduce the potential for damage.

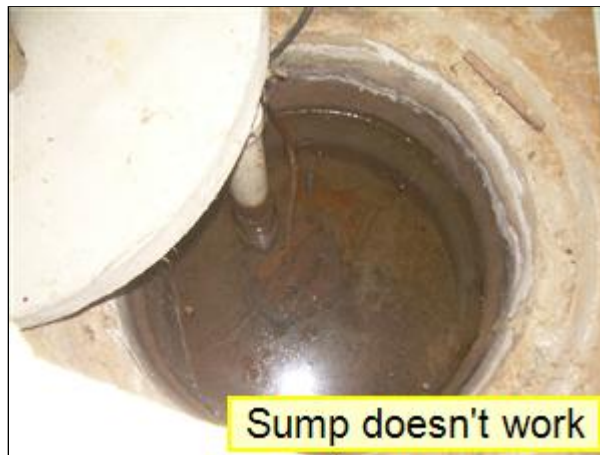
5.6 Picture 1

The sump pump float doesn't activate the pump. Engage a licensed plumber to repair the non-functioning sump pump to reduce the potential for moisture intrusion.

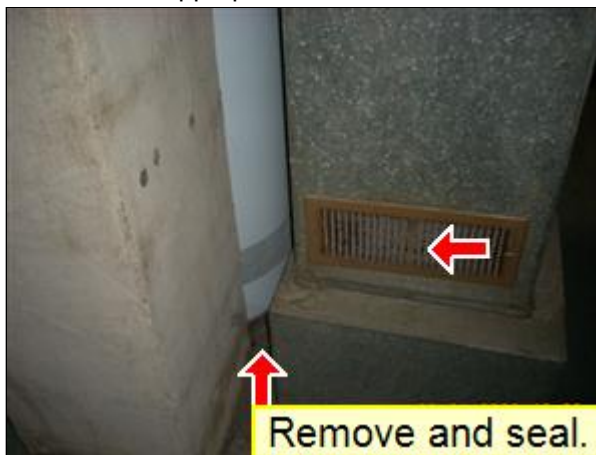
6.2 Picture 1

MAJOR: Someone has installed an air return vent in the return line but it is only 2 feet away from the burner of the gas water heater. This will allow the return to pull carbon monoxide from the water heater burner and distribute the CO into the home. Remove the vent and seal over with appropriate sheet metal. This is a safety issue that must be corrected.

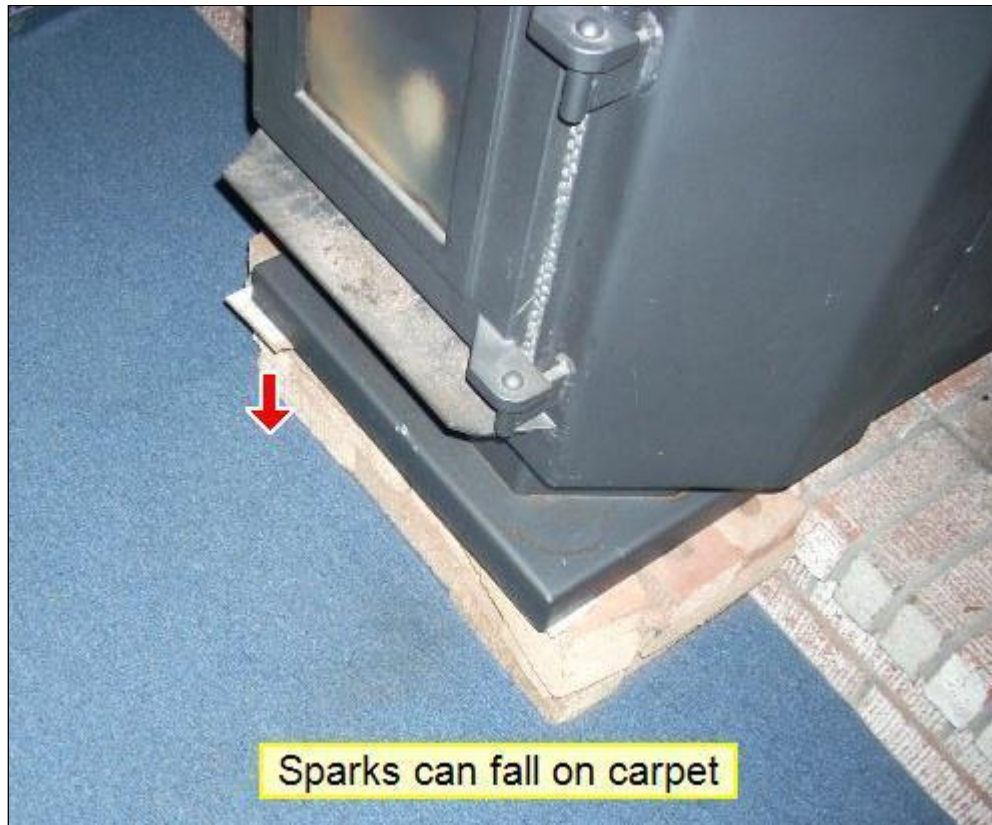
6.5 Picture 1

(1) Woodstove requires a 16 inch non-combustible surface in front of it to reduce the potential for fire. Engage a licensed chimney sweep or masonry contractor to inspect and repair as needed.

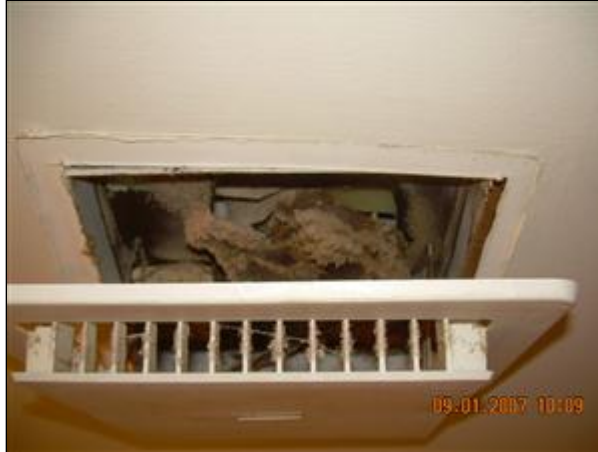
7.4 Picture 1

(1) The exhaust fan did not work at the master bath. It is probably better to replace this rather than repair. Engage a licensed electrician to replace the fan but the duct work is very dirty and should be cleaned at the same time.

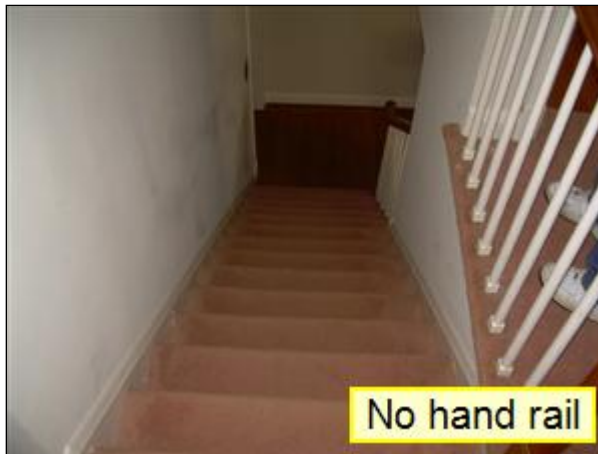
8.3 Picture 1

There is no hand rail on the basement stairs that an individual can grasp if falling. Engage a MHIC licensed contractor to install a graspable handrail on the stairs to reduce the potential for falls.

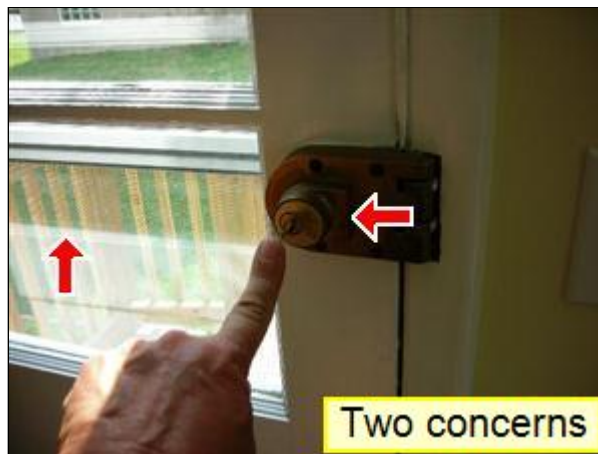
8.5 Picture 1

Keyed interior locks can be confusing or impossible to operate in an emergency. I recommend you remove the keyed dead bolt from the interior of the exit door at the kitchen door to facilitate emergency egress.

The glass panels in the kitchen door are regular glass. Since the home was built, the standard has changed that these should be safety glass. I recommend you have the door reglazed with safety glass to reduce the potential for injury.

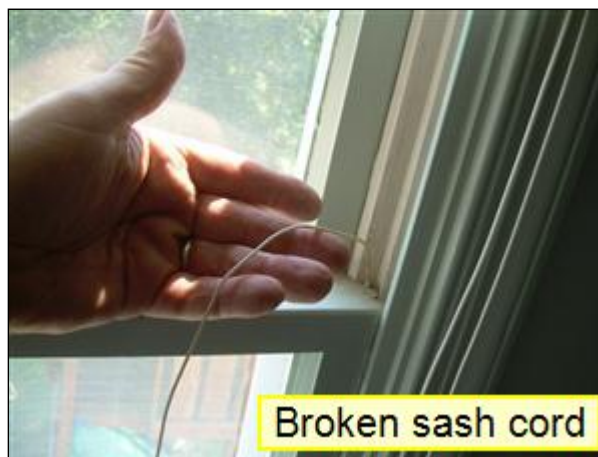
8.6 Picture 1

One of the sash cords has broken to the left hand window in the living room. While the window still operates, the strain will lead to the other cords breaking and may result in the window falling when opened. Engage a qualified person to repair.

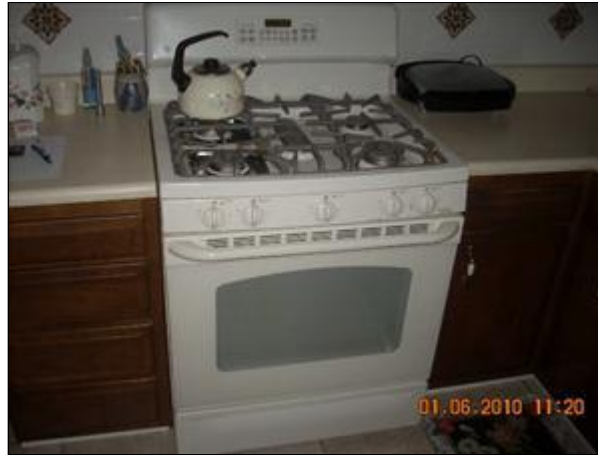
9.1 Picture 1

The gas oven does not have an anti-tip device installed behind. This will allow the stove to tip forward if the oven door is opened and any weight is placed on the open door. Anything on top of the range, including hot objects, can then slide off. I recommend you have a qualified person install an ant-tip device to reduce the potential for injury.

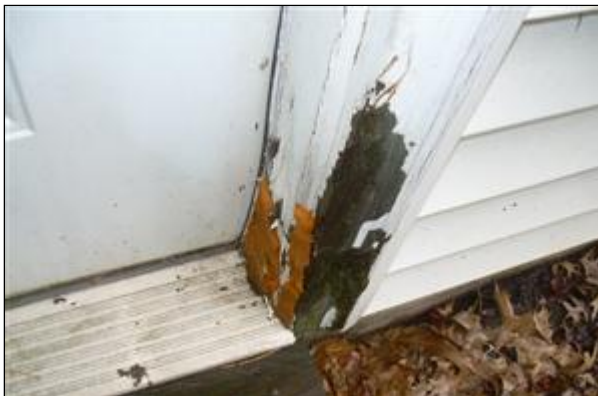
1.4 Picture 1

1.4 Replace the damaged wood trim on the rear exterior door to reduce the potential for additional damage. More damage may be concealed behind the trim.

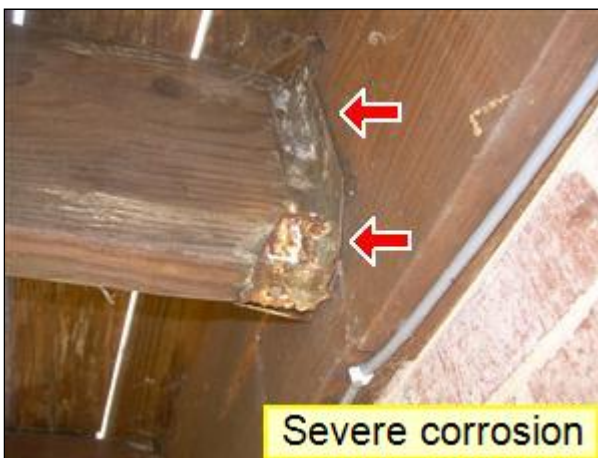
1.8 Picture 1

1.8 Engage a MHIC licensed deck contractor to inspect the deck and replace the rusted joist hangers that have severe deterioration. It appears that the proper hangers were not installed. Given this apparent mistake, have the contractor inspect the entire deck for proper construction.

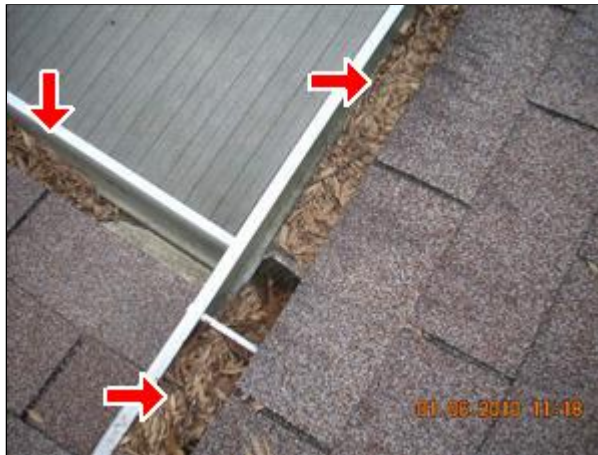
2.1 Picture 1

2.1 The gutters are full of debris in areas and need to be cleaned by any qualified person. The debris in gutters can also conceal rust, deterioration or leaks that are not visible until cleaned, and I am unable to determine if such conditions exist.

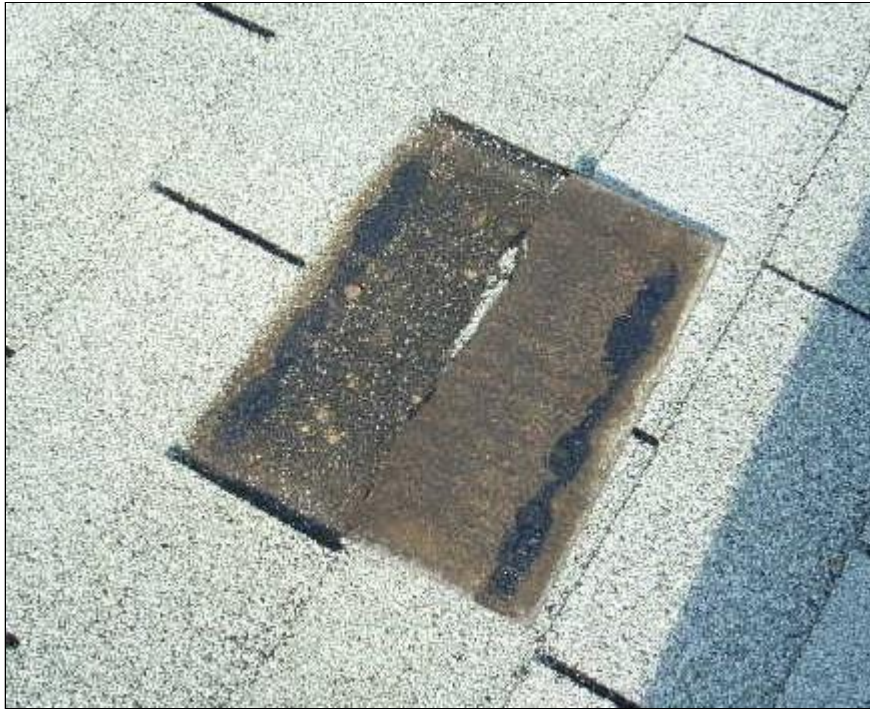
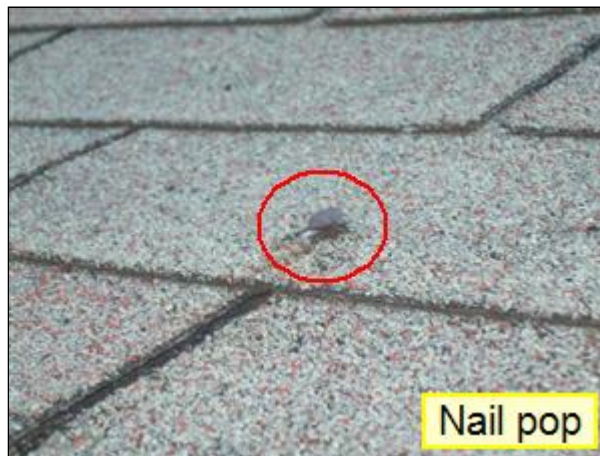
2.2 Picture 1

2.2 The roof has some damaged shingles and nail pops which can allow water intrusion into the home. Additionally, there is water damage that can be seen from the attic near the chimney. Engage a MHIC licensed roofing contractor to repair the shingles and nail pops, and inspect for where the water is leaking into the home near the chimney, to reduce the potential of moisture intrusion and further damage. This roof appears to be near the end of its normal life expectancy and the roofer may recommend complete replacement.

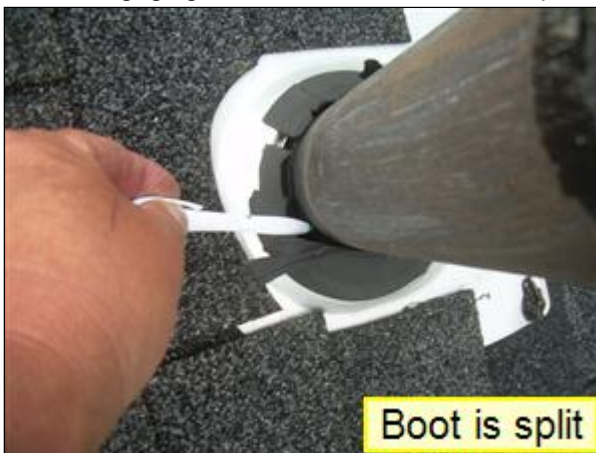
2.3 Picture 1

2.3 The rubber boot around the plumbing vent stack is split. This can allow water intrusion into the home. Caulking will give you a year or two of additional life but engaging a MHIC licensed roofer to replace the boot is better.

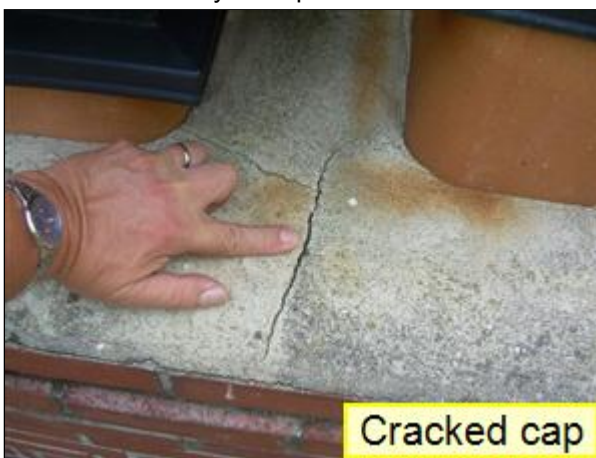
2.5 Picture 1

2.5 The masonry chimney cap is cracked. This can allow water and ice to get in and under the bricks and loosen or damage the bricks. Engage a MHIC licensed chimney sweep or MHIC licensed masonry contractor to inspect and repair.

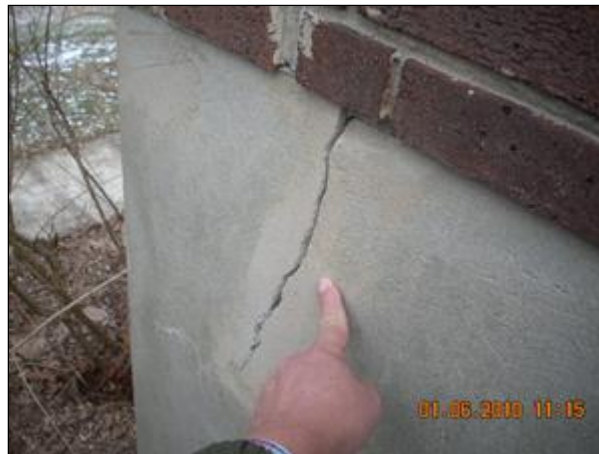
3.0 Picture 1

**3.0** (1) Hairline settlement crack (typical) seen from exterior. No repairs are needed at present. These typical cracks are of no concern

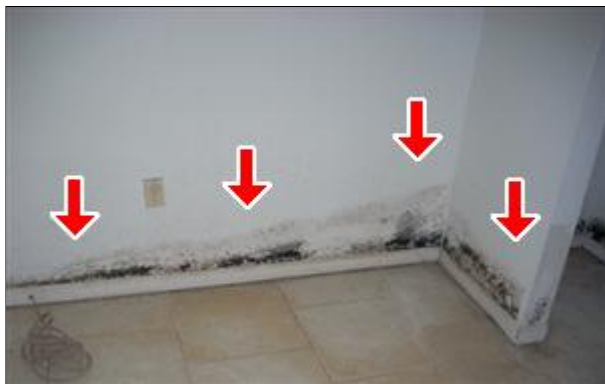
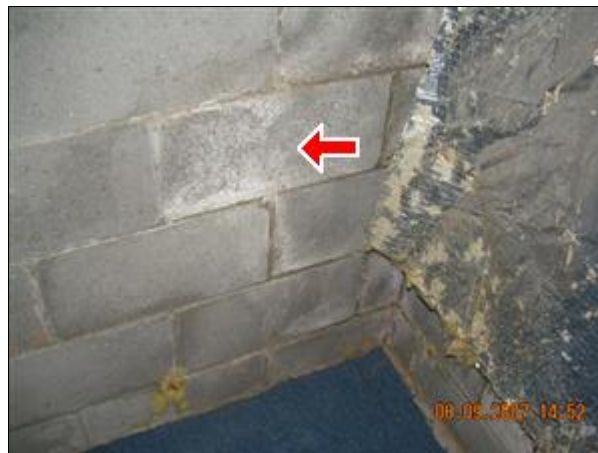
3.0 Picture 2

(2) Major; It is obvious water is coming into the basement at the laundry room wall. The drywall with fungal growth needs to be removed and possibly some of the wood framing behind the drywall. Water intrusion may be caused by lack of adequate grading outside or the clogged gutters overflowing. I recommend engaging a MHIC licensed contractor to inspect and repair as needed.

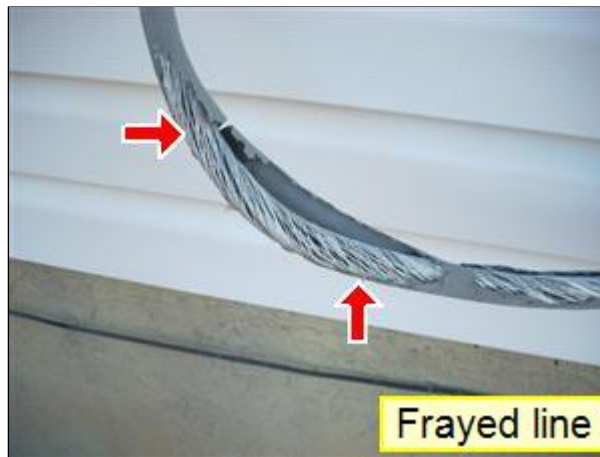
4.0 Picture 1

**4.0** The covering on the service line outside of the home is frayed and someone could get an electrical shock. Engage a licensed electrical contractor to replace the weathered service cable to reduce potential of fire hazard and personal injury.

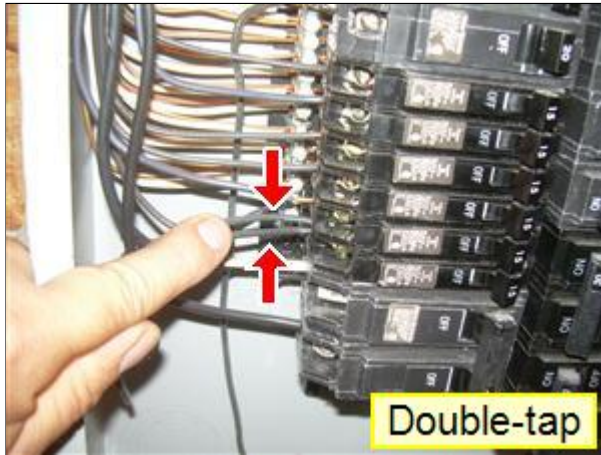
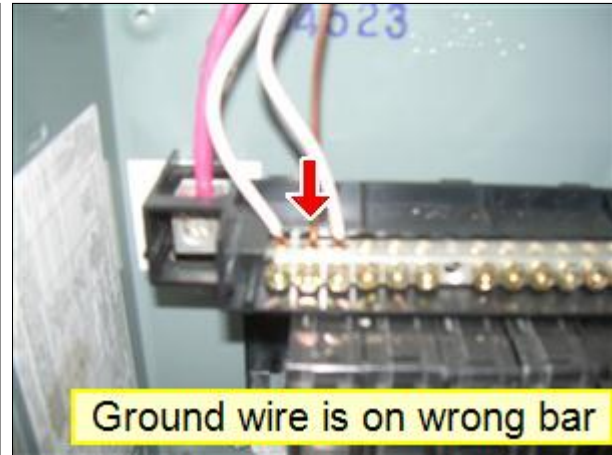
4.1 Picture 1

Engage a licensed electrician to inspect and rewire the secondary panel as needed. The ground wires and neutral wires need to be separated in a secondary panel and there is one ground wire in the secondary panel that is attached to the floating neutral bar.

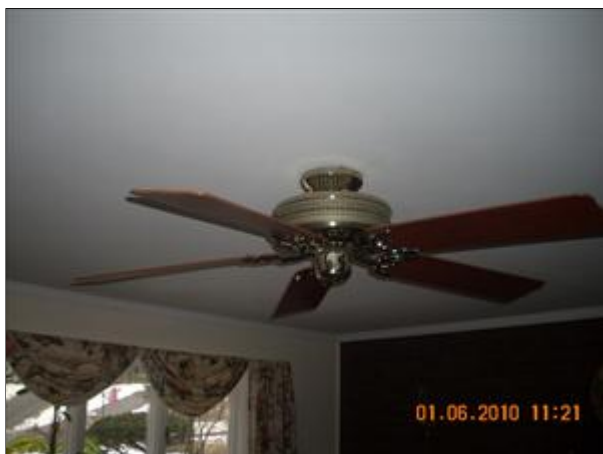
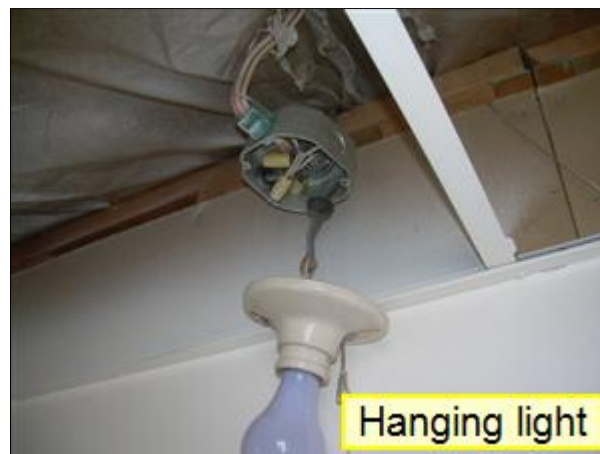
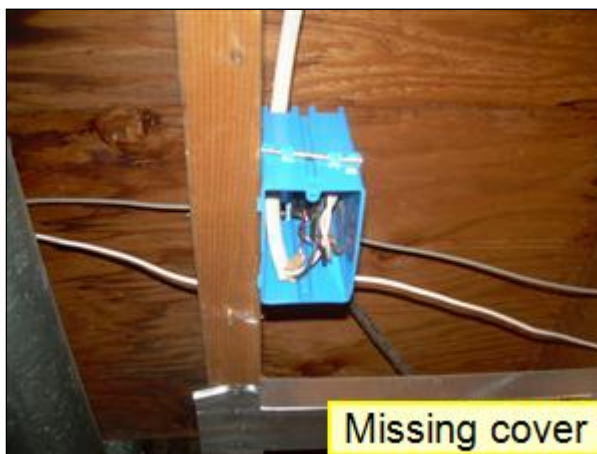
4.3 Picture 1

**4.3** The ceiling fan "wobbles" dining room. This is a simple repair, have a qualified person balance the fan.

The light fixture is damaged and at the rear of the basement. Electrical issues are considered a hazard until repaired. A qualified licensed electrical contractor should perform repairs that involve wiring.

Replace the missing cover on the junction box on the rear ceiling basement to reduce the potential for injury.

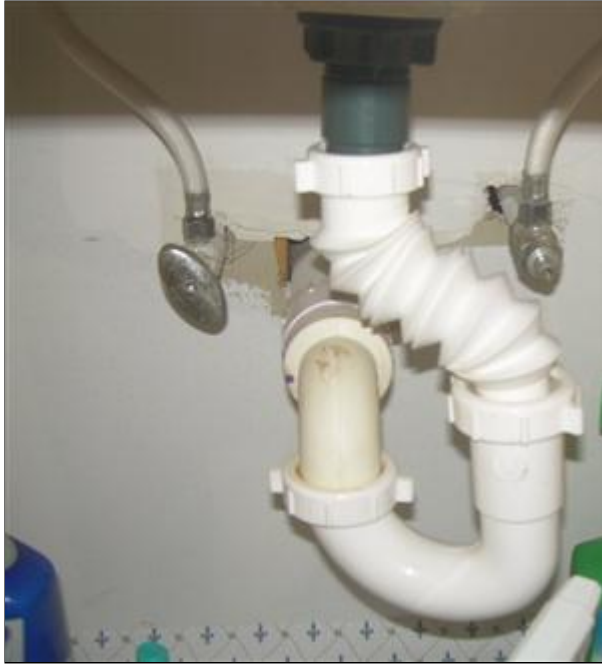
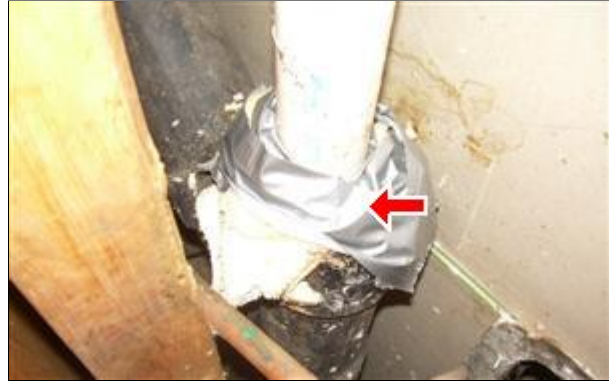
5.0 Picture 1

**5.0** Many "do-it-yourselfers" use the flexible traps for remodeling. All waste and drain lines are required to have smooth interiors so these flexible traps cannot be considered as permanent. Replace the temporary repair trap parts under the sink in the hallway bath with UPC approved parts to reduce the potential of leaks or flooding.

Engage a licensed plumber to repair the incorrect waste drain/air vent connection behind the basement access panel for the basement bath to reduce the potential for damage.

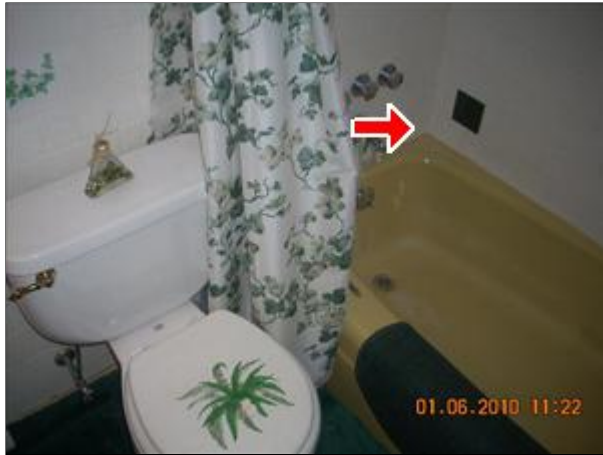
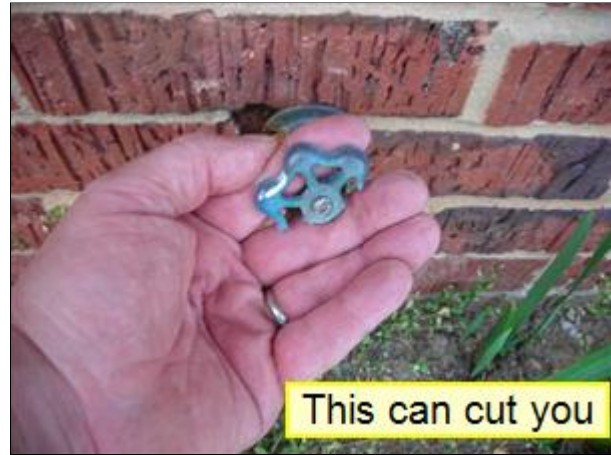
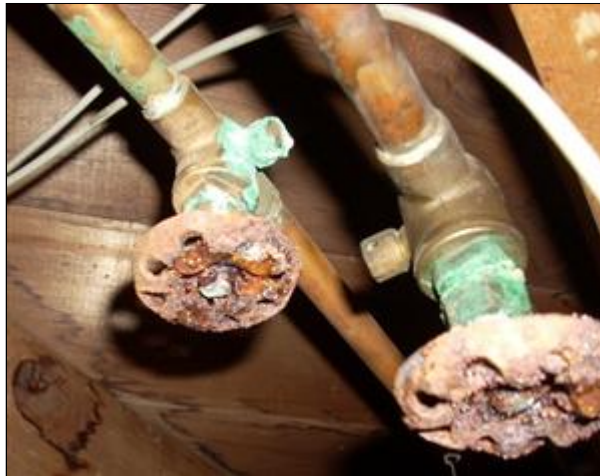
5.1 Picture 1

**5.1** (1) FYI - I recommend you replace the rubber hoses to your clothes washer with stainless steel braided hoses to reduce the potential for a hose rupture.

(2) Replace the broken handle on the exterior hose bibb at rear of the home to reduce the potential for personal injury.

Engage a licensed plumber to replace or repair the heavily corroded cut-off valves leading to the laundry to reduce the potential for water damage and restore function as intended.

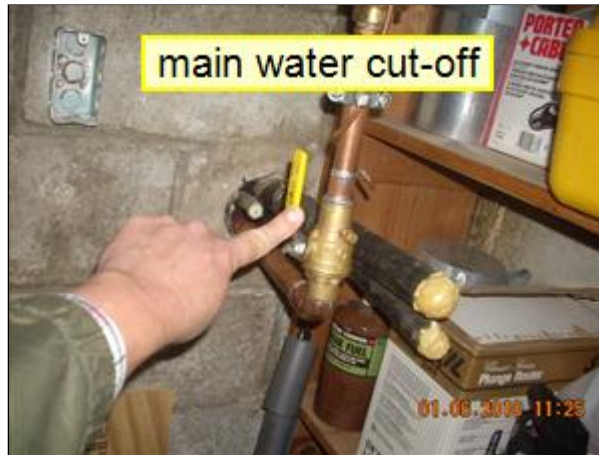
5.3 Picture 1

5.3 FYI - I'll put a tag on this so you don't forget.

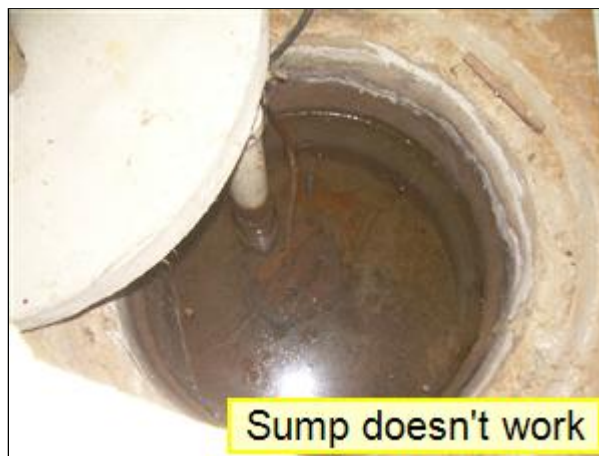
5.6 Picture 1

5.6 The sump pump float doesn't activate the pump. Engage a licensed plumber to repair the non-functioning sump pump to reduce the potential for moisture intrusion.

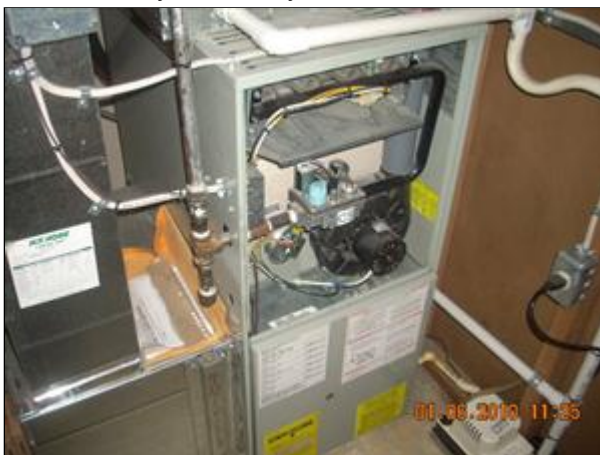
6.0 Picture 1

**6.0** Heating and cooling equipment lasts longer, works more efficiently, and have less chance of developing mold or operational issues if they are serviced regularly so I recommend you engage a licensed HVAC contractor to provide annual maintenance to promote system efficiency and safety. Make sure to remember to change the filters each month.

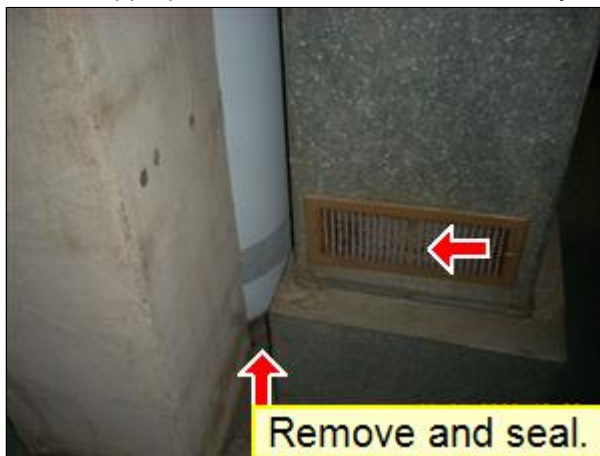
6.2 Picture 1

**6.2 MAJOR:** Someone has installed an air return vent in the return line but it is only 2 feet away from the burner of the gas water heater. This will allow the return to pull carbon monoxide from the water heater burner and distribute the CO into the home. Remove the vent and seal over with appropriate sheet metal. This is a safety issue that must be corrected.

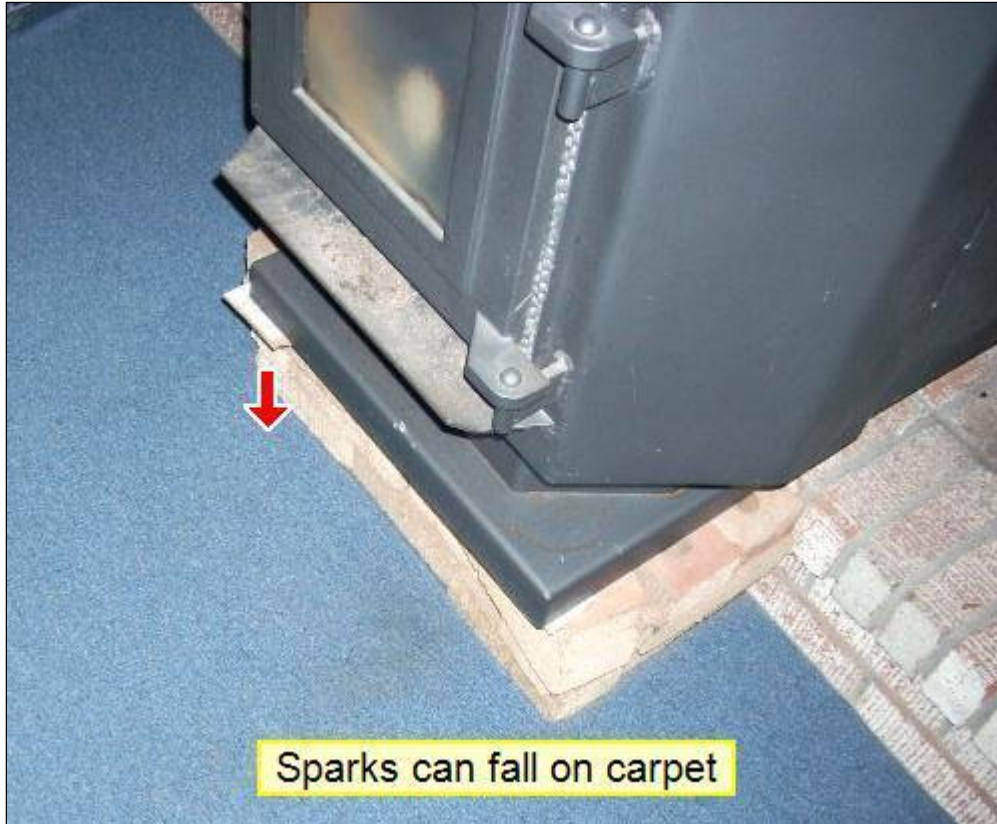
6.5 Picture 1

6.5 (1) Woodstove requires a 16 inch non-combustible surface in front of it to reduce the potential for fire. Engage a licensed chimney sweep or masonry contractor to inspect and repair as needed.

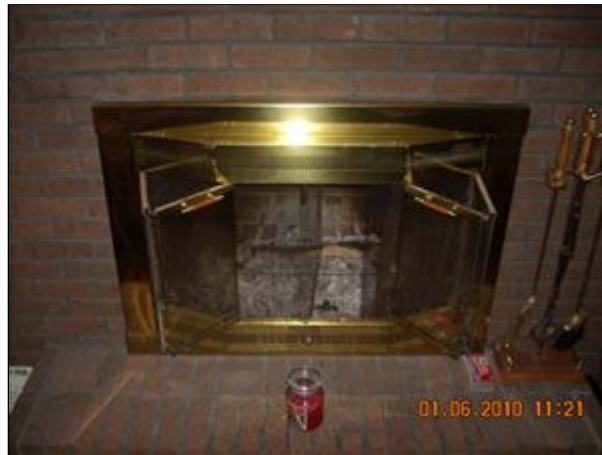
6.5 Picture 2

(2) Fireplaces and chimneys need to be cleaned regularly.

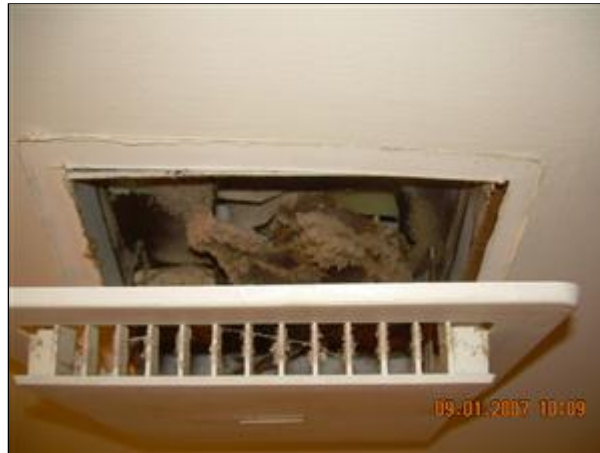
7.4 Picture 1

7.4 (1) The exhaust fan did not work at the master bath. It is probably better to replace this rather than repair. Engage a licensed electrician to replace the fan but the duct work is very dirty and should be cleaned at the same time.

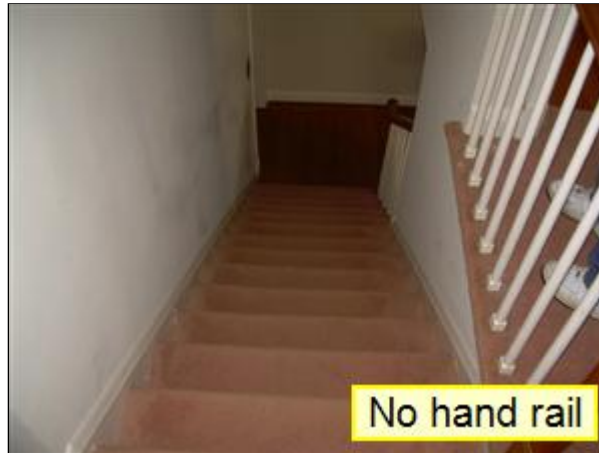
8.3 Picture 1

**8.3** There is no hand rail on the basement stairs that an individual can grasp if falling. Engage a MHIC licensed contractor to install a graspable handrail on the stairs to reduce the potential for falls.

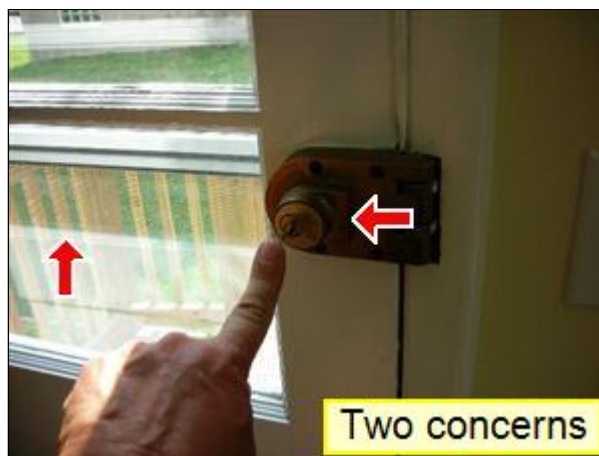
8.5 Picture 1

The glass panels in the kitchen door are regular glass. Since the home was built, the standard has changed that these should be safety glass. I recommend you have the door reglazed with safety glass to reduce the potential for injury.

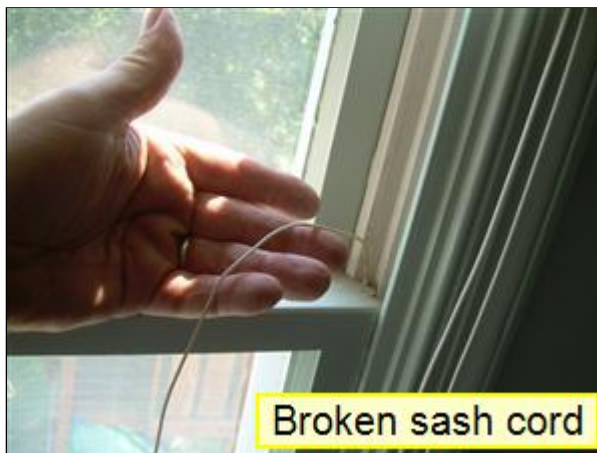
8.6 Picture 1

8.6 One of the sash cords has broken to the left hand window in the living room. While the window still operates, the strain will lead to the other cords breaking and may result in the window falling when opened. Engage a qualified person to repair.

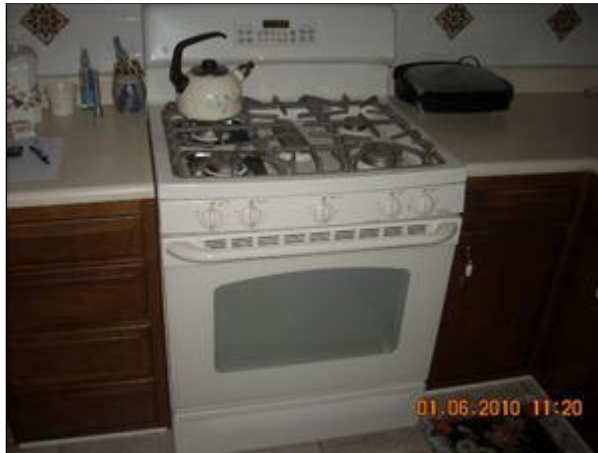
9.1 Picture 1

9.1 The gas oven does not have an anti-tip device installed behind. This will allow the stove to tip forward if the oven door is opened and any weight is placed on the open door. Anything on top of the range, including hot objects, can then slide off. I recommend you have a qualified person install an anti-tip device to reduce the potential for injury.
